J5	TRANSMISSION CONTENTS	4	1
		Pages	
B - TORQUE TUBE AND TRANSMISSION SHAFTS			
Viscous coupling			
Replacing the bearings		B5.001 to 003	
C - TRANSVERSE DRIVE SHAFTS			
Data			
Transverse drive shaft data		C1.001 to 003	
Removing - refitting			
Removing - refitting the transverse drive shafts		C4.001 to 003	
Overhauling			
Working on drive shafts		C5.001 to 005

# DRIVE SHAFT

## OVERHAULING A DRIVE SHAFT

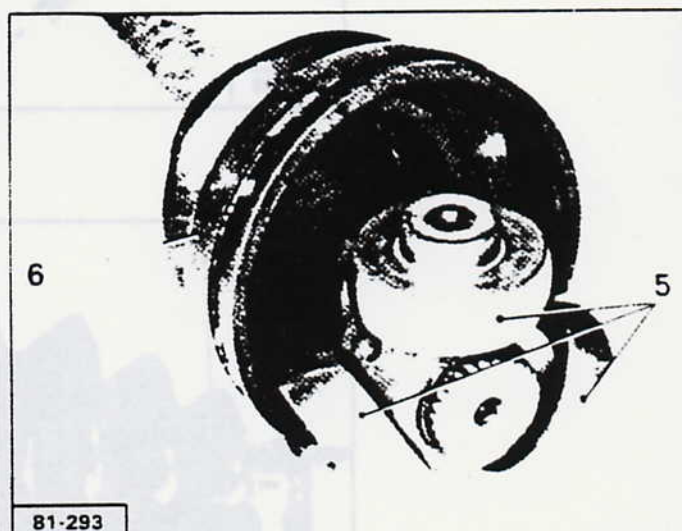
81-293

<ul style="list-style-type: none"> <li>- Fit extractor Facom U53T and cross piece U53S behind the flange and remove it.</li> </ul>

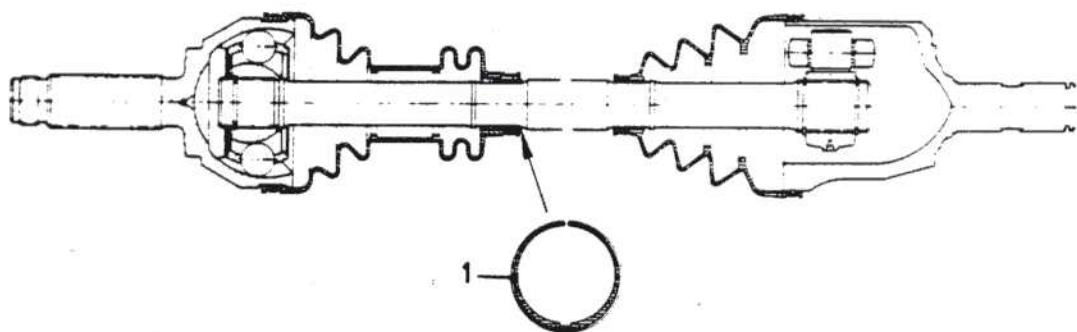
UT. 37-2

- One ball type constant velocity joint at the wheel end.
- One spider joint at the gearbox end.

Left hand drive shaft Fig. I and right hand drive shaft for engine XUD9A

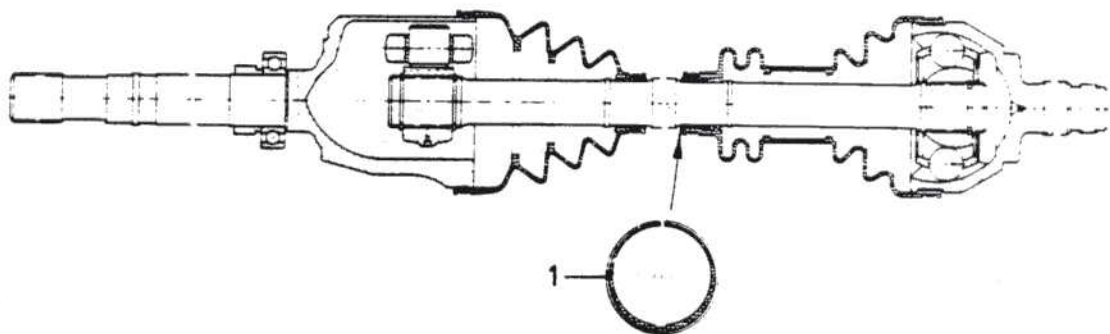
UT. 37-1

Right hand drive shaft Fig. II except for engine XUD9A  
(1) Vent bush.

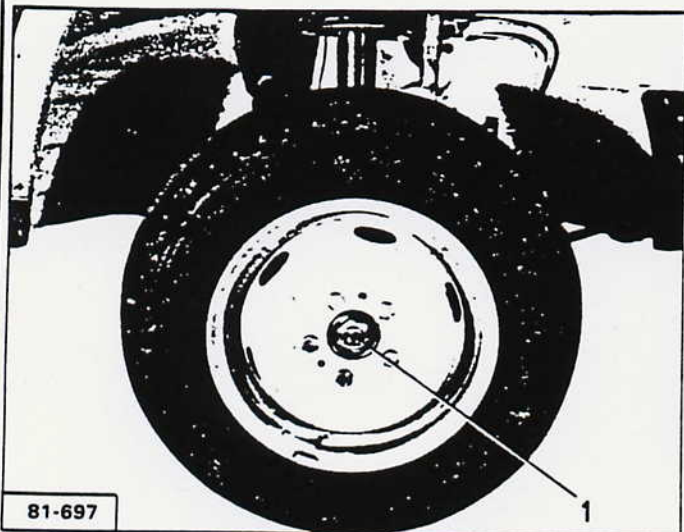
From the front hubs : figs. I and II

Remove the protective hub cap which covers nut (1).

Unlock the hub nut (1) and remove it.

Lower the vehicle on to its wheels : Fig. I.

Tighten and lock the hub nut (1). Its tightening torque is 50 m.daN\* (500 Nm, 370 lbf ft) with faces and threads greased) and it is to be locked at two points.

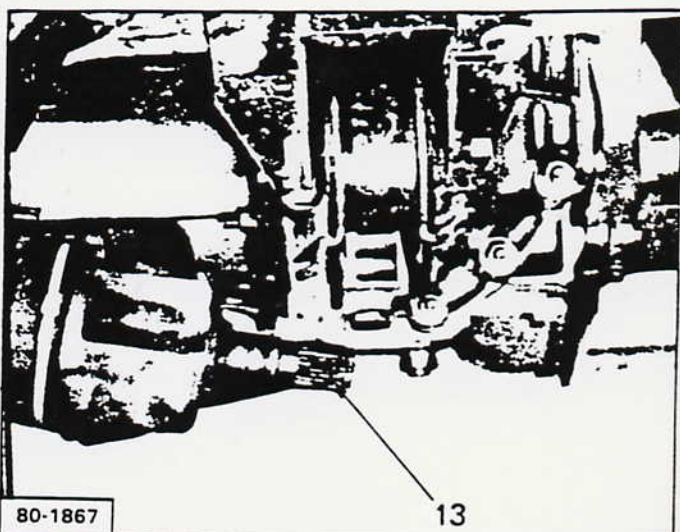
IV

Left hand side : Fig. IV.

Check that the "O" ring seal is in place on the shaft and fit a new circlip (13).

Ensure that the circlip enters fully into its location within the sun gear.

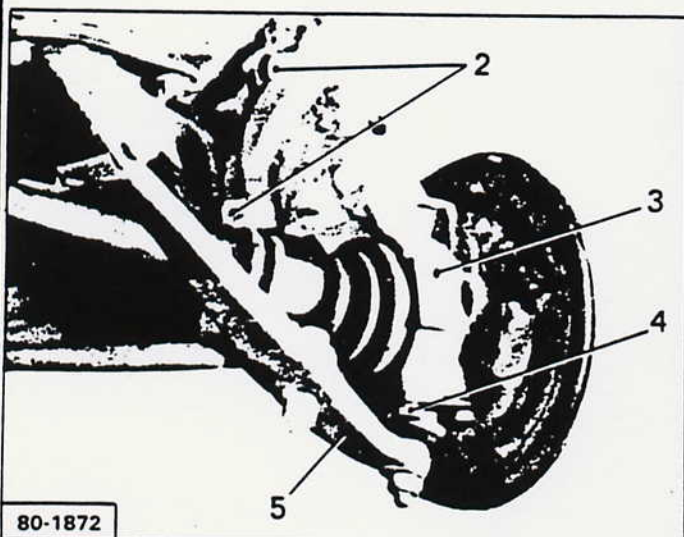
Remove the bolts (4) that secure the lower ball joint and the bolts (2) that secure the steering lever.

Tilt the entire suspension assembly (3) towards the outside.

Free the pivot ball joint by pushing arm (5) : fig. II, downwards.

Withdraw the drive shaft from the hub.

On both front hubs : Fig. II

Pass the drive shaft through the hub (grease the area on which the dust seal will bear).

Engage the ball joint in the stub axle by pushing on the suspension arm.

Fit the steering lever bolts (2) and the lower ball joint bolts (4).

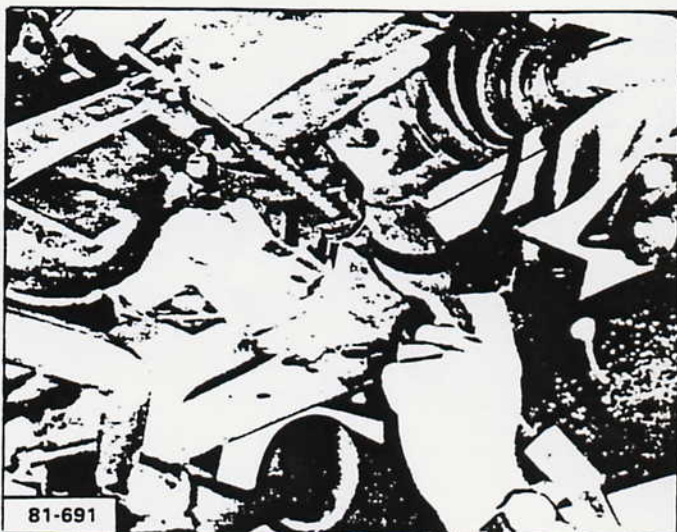
On the left hand side : Figs. V and VI.

Extract the drive shaft from the differential housing with a panel beater's drift (the drive shaft is retained in the sun gear by a circlip).

Push the drift between one of the differential housing bolts and the drive shaft yoke as shown in fig. V, then strike it, in a sideways direction, as shown in fig. VI.

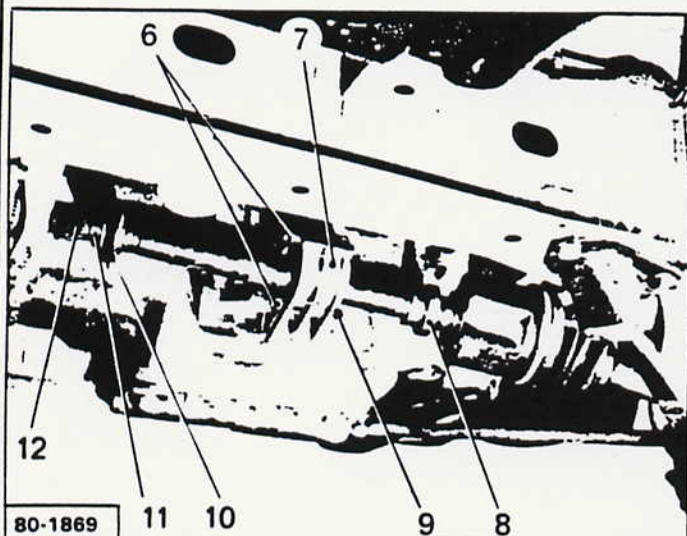
On the right hand side : Fig. III

Loosen the two nuts (6) and swing down the tie rods.

Remove the drive shaft, the "O" ring, the teflon ring and the dust seal.

Right hand side : Fig. III

Insert the drive shaft into the support bearing at (7).

Fit to the shaft :

- the dust seal (1),
- the ring (11),
- the "O" ring (12).

Fit the bearing race (8) to the bearing support (7).

Swing the tie rods (9) through half a turn so that they grip the bearing outer track.

Tighten the self locking nuts (6) to a torque of 0.7 m.daN (7 Nm, 5 lbf ft).

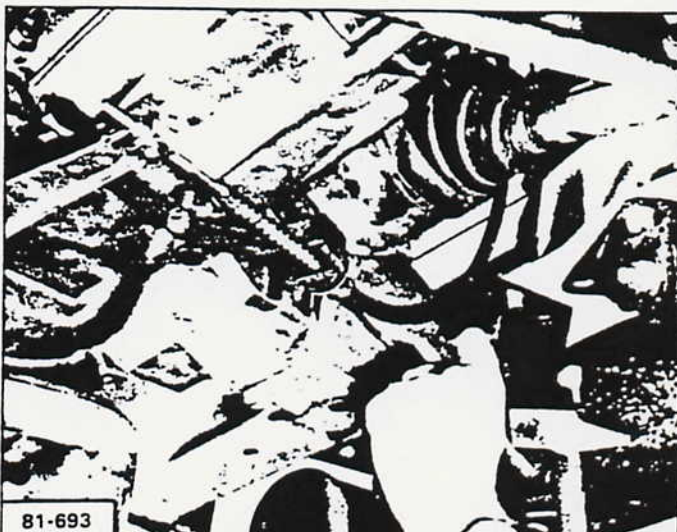
VI

Withdraw the drive shaft from the final drive.

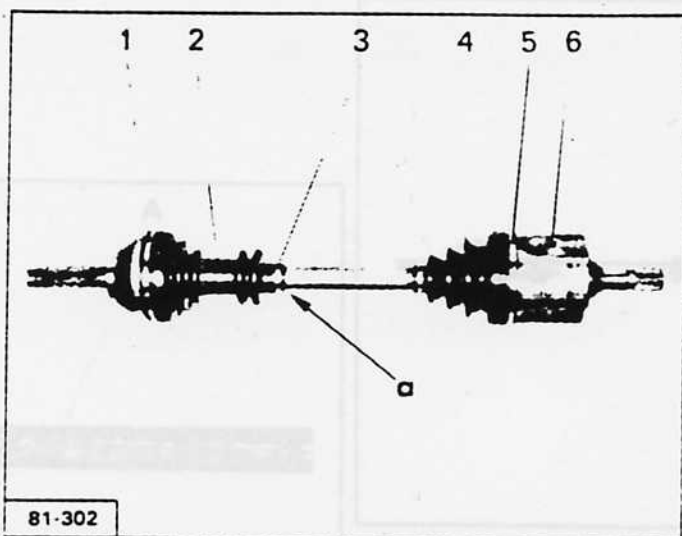
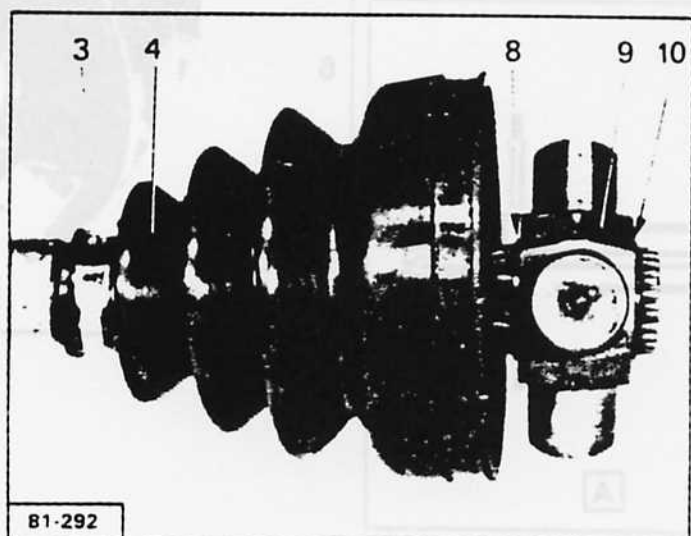
Removing the drive shaft drive end : fig. I

Remove the clip (2) and take off the drive end (1).

Removing the circlip (3) and bearing (4) : figs. II and III.

Carry out these operations with the extractor  
[A] FACOM U53T2 fitted with its extensions.

Fitting the bearing (4) : fig. IV.

Fit the bearing using the tube A (i.d. = 36 mm, length = 450 mm).

Coat the roller (5) with grease and fit them to the spider : fig. V.
